# NASA/TP-1998-207645

# Evaluation of Composite Honeycomb Sandwich Panels Under Compressive Loads at Elevated Temperatures

Sandra Walker Langley Research Center, Hampton, Virginia

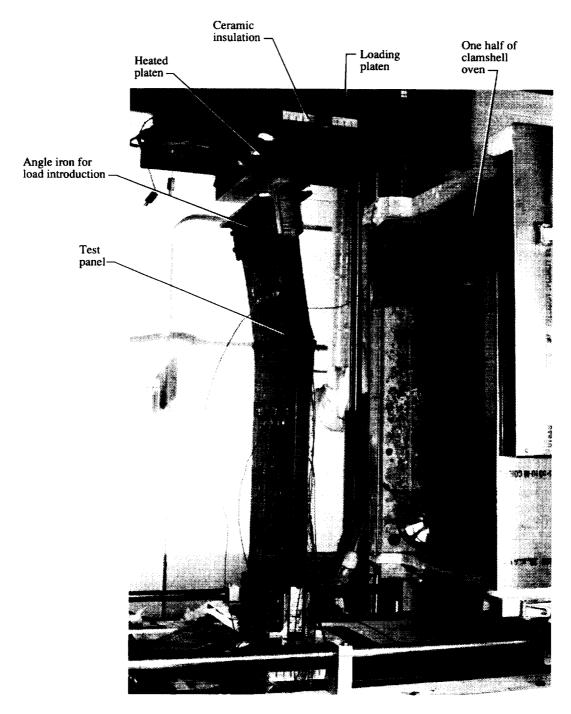
Figure 4. Photograph of failed panel located in test stand.

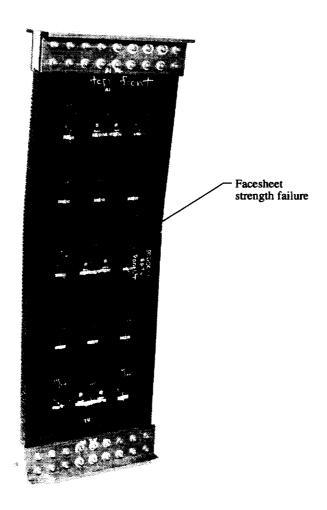
All 8-ply specimens failed due to facesheet fractures which is referred to as the facesheet strength failure mode. All panels referred to in Table 3 as having failed in the facesheet strength mode, were very similar in appearance.

Figure 8 is a photograph of Panel 4 after failure which is typical of the appearance of all panels that failed in the facesheet strength mode. Increasing the test temperature from room temperature to 300°F did not appear to effect the failure mode for the 8-ply specimens. In comparing the failure data of the 8-ply titanium core panels with the 8-ply graphite-polyimide core panels, the effect of the type of core on the structural performance in compression is inconclusive.

Figure 8. Photograph of Panel 4, with 8-ply facesheets, after testing to failure.

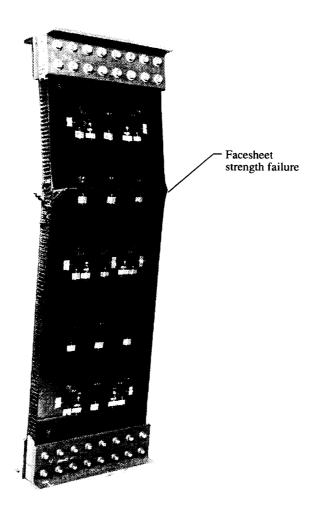
For the 24-ply specimens, buckling of the panels prior to failure was observed for both the room and 250°F temperature tests, as indicated in Table 3. However, ultimate failure of the 24ply panels at the room and the 250°F test temperatures was initiated by fracture of the facesheets well above the design allowable strain. Figure 9 is a photograph of Panel 11 which buckled prior to failure and is typical of the appearance of all failed 24-ply panels that experienced buckling before failure. For the 24-ply specimens, increasing the temperature from 250°F to 300°F resulted in a different failure mode. At 300°F, one 24-ply panel experienced a facesheet strength failure, and the other 24-ply panel experienced disbonding between the facesheet and core material. Figure 10 is a photograph of Panel 14 which failed in the disbond mode. The failure modes at 300°F can be attributed to a reduced strength of the facesheets and adhesive due to increasing temperature. Also, it is important to note that Panel 14 had potted ends only and thus did not have an associated clamp-up pressure that might prevent a disbond failure mode from occurring.

Figure 9. Photograph of Panel 11, with 24-ply facesheets, which buckled prior to failure.

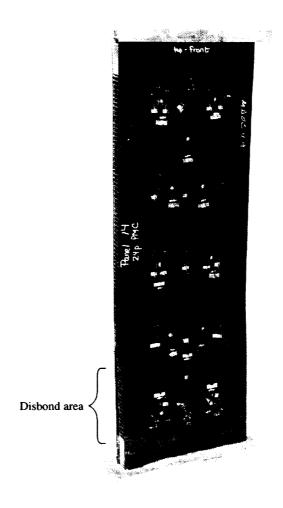
Figure 10. Photograph of Panel 14, with 24-ply facesheets and potted ends only, after testing to failure.
